# Manhole Inspection Summary

Manhole # S19Y\_\_005MH

Insp Date: **6/4/08 1:21 PM**

**Location** Address: **2413 harman av**

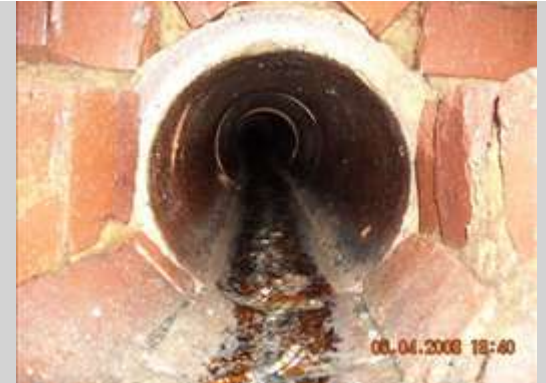
12 O'Clock Outflow

8 in. Circular Gravity Sewer  
Pipe Out @ 12 O'Clock

Pipe Height: **8.4** (in.) Rod and Bar (Angled)  
Pipe Material: **Clay** ☐ Pipe Lined  
Invert Depth: **14.30** (ft.) Flow Characteristics: **Slow**  
Deposits: ☒ None ☐ Mud ☐ Sludge ☐ Debris ☐ Grease  
Silt Depth: **0** (in.) Deposits Extent:  
Infiltration: **None** Pipe Seal Cond: **Sound**

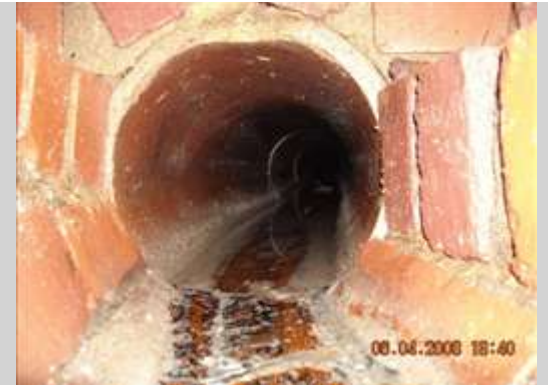
9 O'Clock Inflow

Pipe In @ 9 O'Clock

Pipe Height: **8.4** (in.) Rod and Bar (Angled)

Infiltration: **None** Pipe Seal Cond: **Sound**
